Review of Major Dams and an Examination of Watershed Fragmentation

Report prepared by
Pinnacle Consulting Group
A Division of North Wind, Inc.

Submitted to
Saluda-Reedy Watershed Consortium

27 July 2005

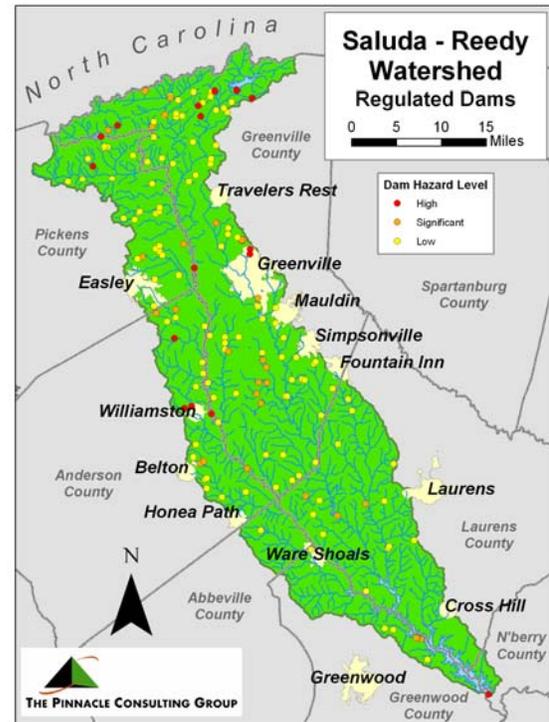
Figure 1: Regulated Dams in the Saluda-Reedy Watershed

Regulated dams were fairly evenly distributed across the SRW with small clusters in the central watershed and slightly denser distributions in the northern reaches corresponded by less dense distributions in the southern reaches of the SRW. (See Figure 1: Saluda-Reedy Watershed Regulated Dams (opposite), and Table 2: Dams Categorized by HUC-11 Watersheds

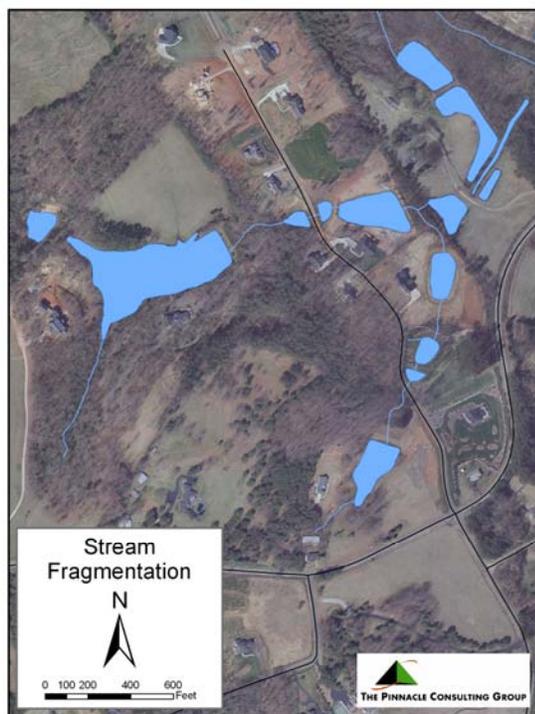
Figure 2: Stream Fragmentation – Ponds in Upper Reedy River Basin of Greenville County – 2003 Imagery

(Note: This observation does not account for the thousands of sediment and stormwater detention ponds ever more ubiquitous on the landscape, especially at the heads of, or along the course of ephemeral drainages). For an example of one of the denser areas of impoundments see Figure 2: Stream Fragmentation *(next page)*.

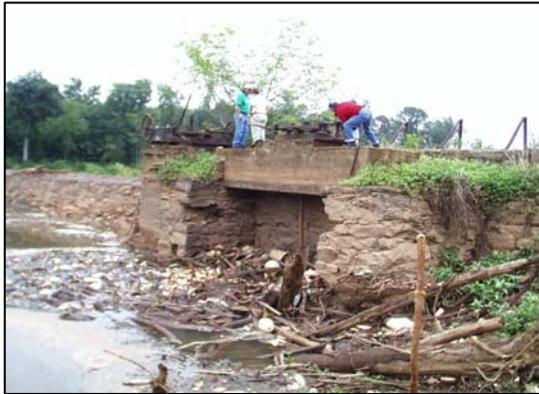
Photo 1: Lake Conestee Dam, ca. 1892, on the Reedy River, Greenville County. View of dam from upstream with partially open gate, August 2000. Note dilapidated gate assembly and accumulated trash and debris.

The Lake Conestee dam presents a unique situation which underscores a variety of management issues that can befall old dams. This dam is a stone masonry structure believed to have been constructed about 1892 on the Reedy River about six miles south of Greenville. Other dams had existed at this location as early as the 1830’s or even earlier. This dam originally had a movable gate, which was typical of most dams of this design. (See Photo 1).

On about June 01, 2000 the gate assembly of the dam unexpectedly opened. It was determined that the gate had gradually decayed and had lost its ability to function as a gate probably decades ago. Examination of conditions following the breach event, indicated that what had been thought to be an intact gate was evidently simply a log-jam. Due to the lack of maintenance of this primary water level control feature of the dam, the gate gradually decayed and was replaced with a dense log jam. During a severe drought which began in 1998, streamflows were dramatically reduced, and with that the predictable delivery of large woody debris to replenish the log-jam essentially ceased. The debris in the eight-foot diameter gate orifice, which was sufficient to hold back the river and keep the lake full to the top of the dam under ordinary streamflow conditions, decayed to a point where it abruptly broke through. This allowed the lake to de-water over a matter of hours. The gate remained open from June 01, 2000 to June 21, 2001. This occurred shortly after the purchase of the lake and dam by the Conestee Foundation, a non-profit group formed to rehabilitate the lake and surrounding parcels into a public park.

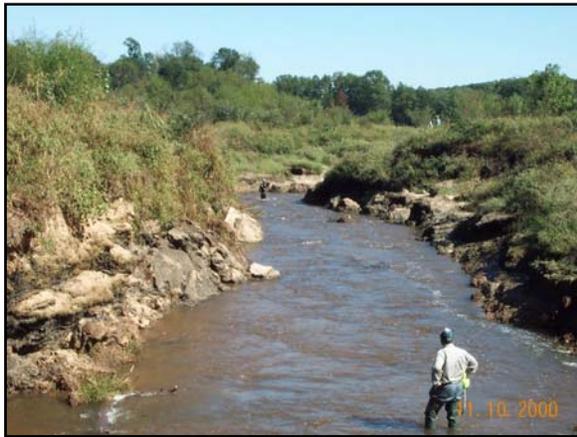
Photo 2: “Conestee Canyon” as seen looking downstream during a cross-sectional survey of the river channel on 10 November 2000.

During this twelve month period, the Reedy River, flowing through Lake Conestee, steadily cut down through the lake’s accumulated sediments. This was a natural and predictable process of erosion wherein an impounded river, upon accessing its original base level, will dissipate energy by eroding the channel down to that base elevation. (See Photo 2).

Two NRCS surveys of the eroded “Conestee Canyon” channel were conducted during the one year of open-dam conditions. These surveys determined that roughly 95,000 cubic yards of sediments were flushed from the lake downstream during this period.

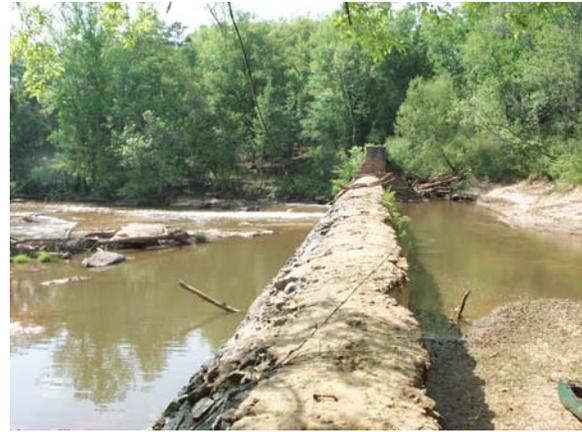
Photo 3: Cedar Falls Dam – note canoe in bottom right for scale. Lower Greenville County.

One potential candidate for removal is Cedar Falls Dam located on the Reedy River approximately 18 miles below the City of Greenville. Currently this century-old stone-masonry and timber-crib dam does not actively impound water or serve any beneficial function. The orifice in the dam is breached except for accumulated woody debris. This dam does have a spillway but only experiences top-of-dam overflows during high water events.

This dam still impounds a small amount of water and a small volume of sediment. Since Cedar Falls Dam does not provide any advantageous uses and only serves to fragment the SRW hydraulic network it may be a prime candidate for removal, once appropriate feasibility and impact issues are addressed. Cedar Falls Dam does currently pose a threat to canoers and kayakers who have to portage the dam and run the risk of being swept through the orifice. Removal of this dam, if justified through further investigation, will serve to improve water quality, enhance recreational opportunities, and improve recreational safety. (See Photo 3: Cedar Falls Dam).

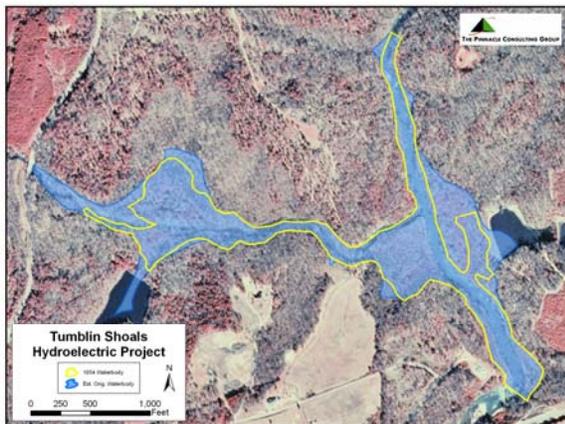
Figure 3: Tumblin' Shoals Hydroelectric Project, The impounded area is portrayed here as reflected in a 1954 aerial photo. The aerial photo displayed is from 1999.

Tumblin' Shoals hydroelectric project was built in 1907 by the Reedy River Power Company near the community of Hickory Tavern, in upper Laurens County. This hydro project was in service for the Reedy River Power Company until it was acquired in 1912 by the Sullivan Power Company. It was next acquired by Duke Power in 1935. This dam was decommissioned and removed by Duke Power in December 1970. (See *Figure 3: Tumblin' Shoals Hydroelectric Project, for an approximated shoreline location as built as in 1954*).

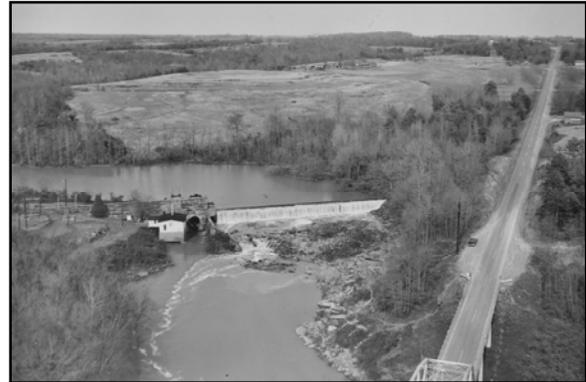
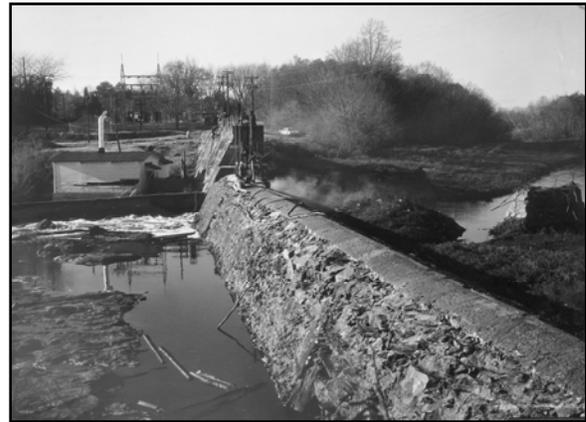
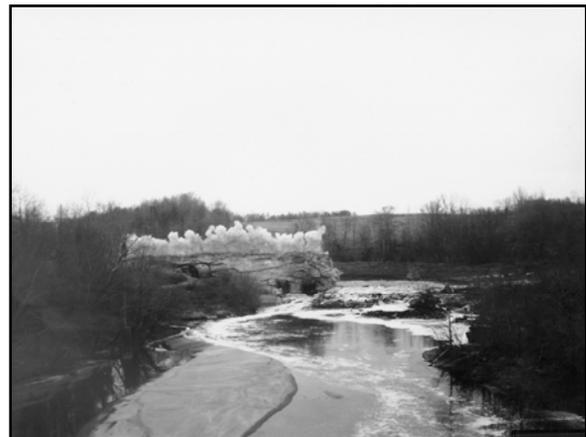
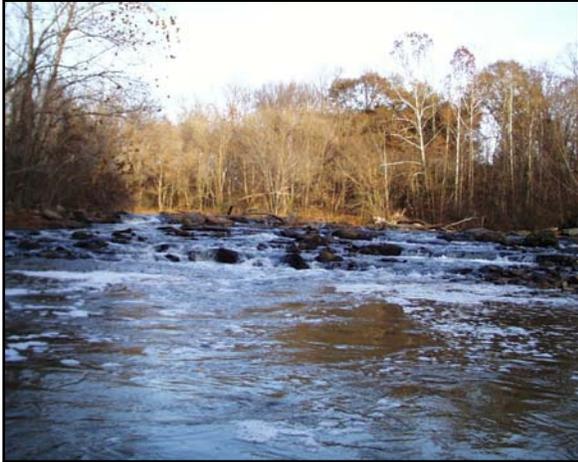
Photo 4: Tumblin' Shoals Dam on the Reedy River in Upper Laurens County, pre-1970.

Photo 5: Tumblin' Shoals Dam Demolition, drilling for placement of explosives, Dec 1970.

Photo 6: Tumblin' Shoals Dam Demolition, Dec 1970.

Photo 7: Tumblin' Shoals in 2002

The following photographs (*Photos 4-7*) depict the removal of the dam at Tumblin' Shoals, and current site conditions.

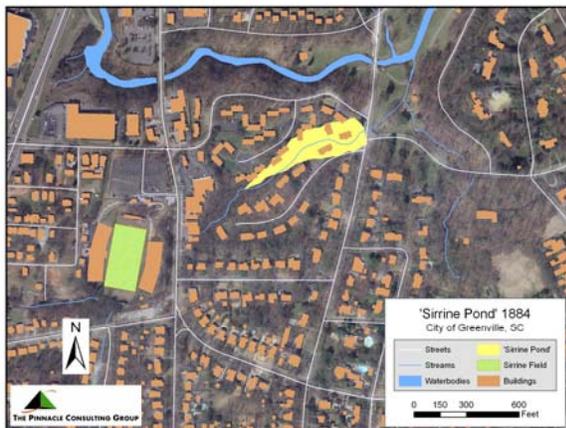
Figure 4: *Sirrine Pond*

“Sirrine Pond,” as it has been named for this project, is located just south of the Reedy River near downtown Greenville. (See Figure 4: *Sirrine Pond*). This pond was

identified on an 1884 map of the City of Greenville. This map was rectified and the pond area transferred into a GIS. *Sirrine Pond* was calculated to be 2.2 acres. Based on current conditions, the historic footprint area of the pond has been filled, and the area is presently occupied by several multi-family dwellings. The dam’s location is very

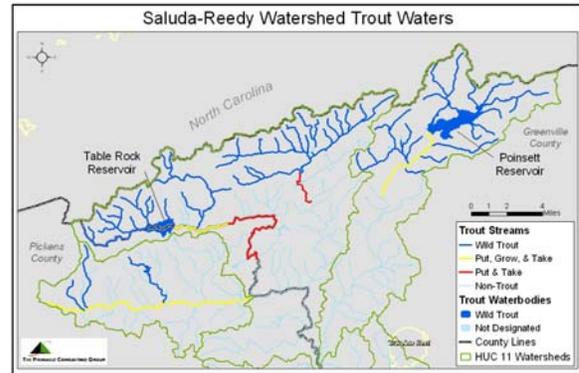
Within the SRW, additional dams for consideration of modification include Poinsett (North Saluda) and Table Rock (South Saluda) Reservoirs along with several smaller impoundments. (See Figure 5: Saluda-Reedy Watershed Trout Waters (next page)). Both of these impoundments are fed by streams that support wild, reproducing populations of trout (Wild Trout). The streams that flow from these reservoirs are not Wild Trout waters, but rather “Put, Grow, & Take” waters. Put, Grow, & Take waters can support trout year-round but due to habitat deficiencies these trout can not successfully reproduce and require a yearly stocking of fish, generally due to elevated temperature regimes. Other habitat deficiencies can include high sediment loads and competitive species. The third category of trout waters are “Put & Take.” These waters are only capable of supporting trout populations during cooler months of the year. The most commonly cited causes for this condition are warm water.

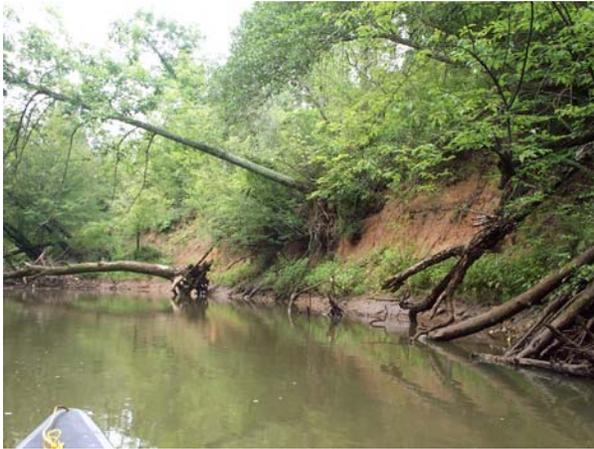
Photo 8: Effects from Erratic Hydroelectric Releases from Boyd Mill Pond Dam. On the Reedy River in Laurens County.

One dam of possible concern is Boyd Mill Pond Dam located on the Reedy River. This facility does generate hydroelectric power but not at a scale sufficient to trigger FERC regulation. Dams such as this, because of their small size and old technology typically operate as “peaking facilities,” and can only operate profitably by producing hydroelectric power at peak power demand times. This production schedule can cause severe fluctuations downstream, much more so than naturally occurring fluctuations in water levels, or “run of the river” conditions. This manipulation of flows often occurs during the hottest, driest, and lowest flow regime conditions of the year, resulting in the most extreme ecological impacts to the downstream aquatic environment. These abrupt changes in flow can also cause stream bank instability, erosion, scour and degraded water quality. (See Photograph 8: Effects from Sporadic Hydroelectric Releases from Boyd Mill Pond Dam). Modifications to this facility’s operational regime should be adopted so that releases

more closely mimic natural “run of the river” conditions.
